FIGURE 8-3: CEDARCREEK ELEMENTARY SAFE ROUTES TO SCHOOL IMPROVEMENT PLAN

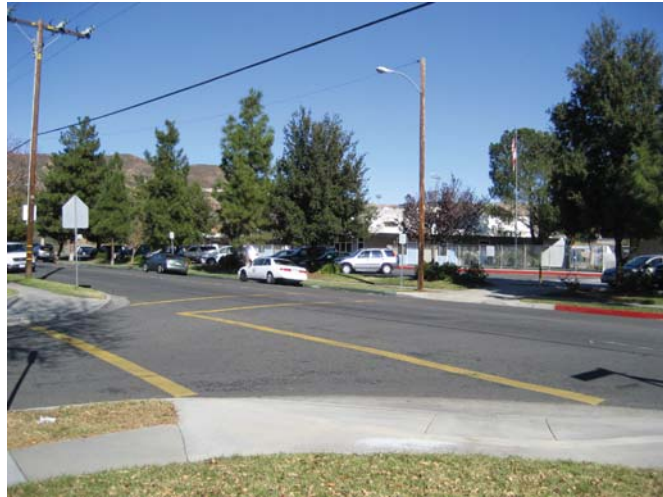
EXISTING CONDITIONS
CAMP PLENTY ROAD AT FOUR OAKS STREET

- Yellow transverse crosswalks at adjacent intersections
- Standard yellow MUTCD school area signage
- Unprotected crossing at intersection of Camp Plenty Road and Four Oaks Street

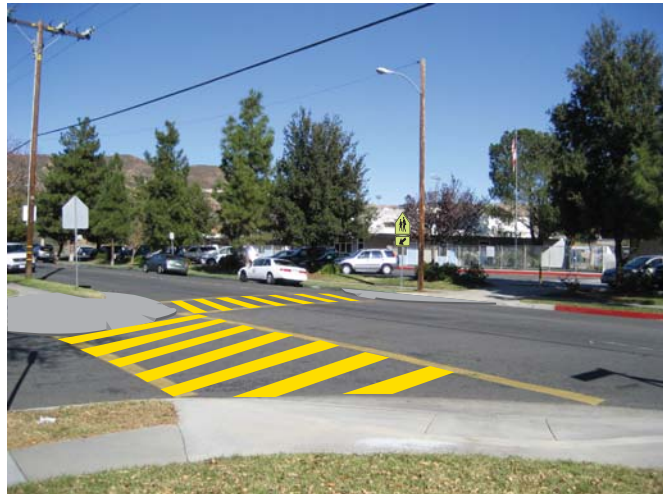
PROPOSED
SIMULATED BULB-OUT AND CROSSWALK IMPROVEMENTS

- Install bulb-outs and ladder-style crosswalks at Camp Plenty Road and Four Oaks Road. Install fluorescent yellow-green Assembly B signage.
- Replace existing transverse crosswalks with ladder-style crosswalks.
- Inventory school area signage to ensure compliance with 2003 California MUTCD. Replace or add signage as needed.
- Replace school area signage with fluorescent yellow-green signage.
- Refresh pavement markings as needed.
